# TEST REPORT

Rep. No. : 24-08-RBD-005  
Applicant : GAINTA INDUSTRIES LTD.  
Address : 1F., No.30, Lane 54, Chung Cheng Road, Hsin Tien District, 23146 New Taipei City, Taiwan  
Commodity : Sealed Plastic Box (PC)  
Model : P20793-IP68  
Serial Model : P20883-IP68 、 P2393-IP68 、 P2393MF-IP68  
Quantity : 3 sets  
Date of Receipt : 2024-08-02  
Date of Testing : 2024-08-08~2024-08-21  
Issue Date : 2024-08-23  
Test Specification : IEC 60529:1989+A1:1999+A2:2013  
Ambient Environment : Temp. 29.6 °C, 53.7 % R.H., A.P. 988 mbar  
Test Item : IP68  
Test Condition & Result : See the following sheets

## 1. Test Item : IP68

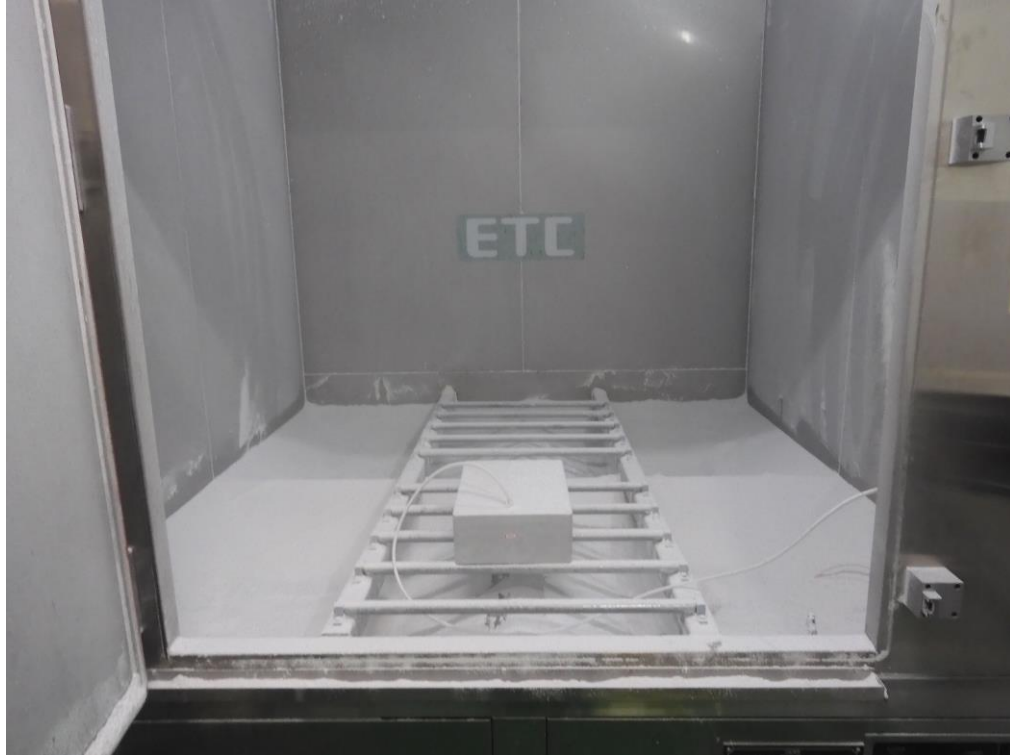
IP6X Test

- Dust : Talcum powder
- The amount of dust : 2 kg/m<sup>3</sup>
- Maximum depression of 2 kPa.(20 mbar).
- The duration of the test is 8 hours  
(Extraction rate of 40 to 60 volumes per hours)

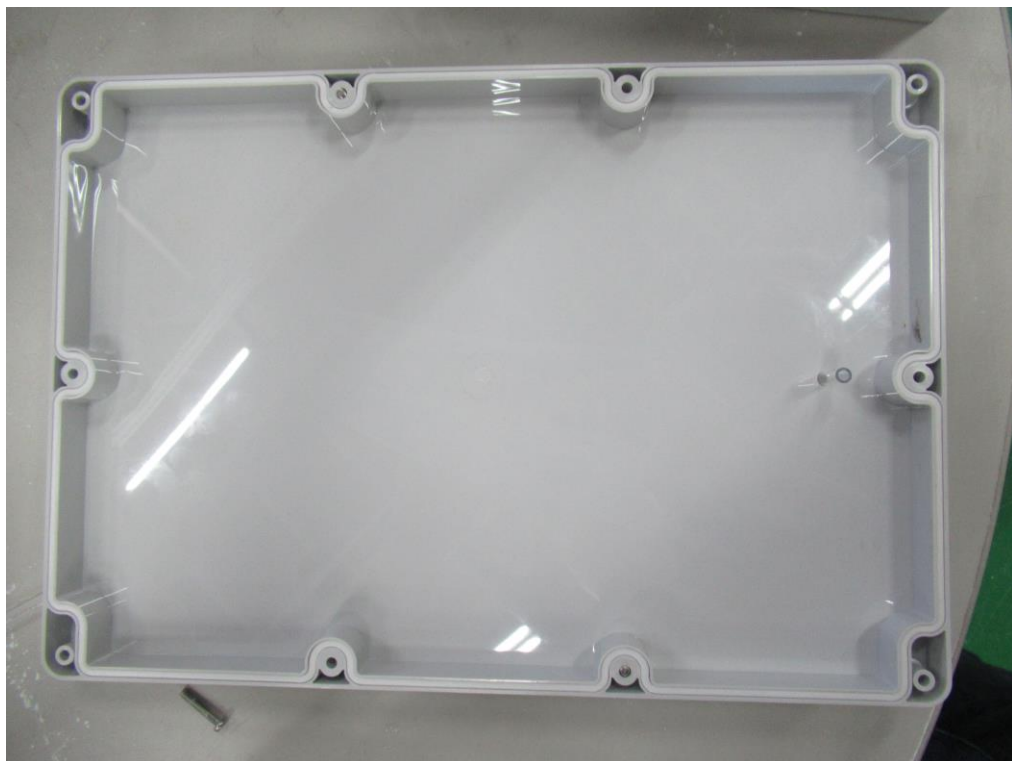
Sealed Plastic Box (PC) P20793-IP68  
IP6X Test - There is no trace of dust inside

Test Item	Test Sample	Results	Acceptance Criteria
IP6X	Sealed Plastic Box (PC) P20793-IP68	There is no trace of dust inside	Refer to the test specification on page 1 of the report
IPX8	Sealed Plastic Box (PC) P20793-IP68	There is no trace of water inside	Refer to the test specification on page 1 of the report
IP6X	Sealed Plastic Box (PC) P20883-IP68	There is no trace of dust inside	Refer to the test specification on page 1 of the report
IPX8	Sealed Plastic Box (PC) P20883-IP68	There is no trace of water inside	Refer to the test specification on page 1 of the report
IP6X	Sealed Plastic Box (PC) P2393-IP68	There is no trace of dust inside	Refer to the test specification on page 1 of the report
IPX8	Sealed Plastic Box (PC) P2393-IP68	There is no trace of water inside	Refer to the test specification on page 1 of the report

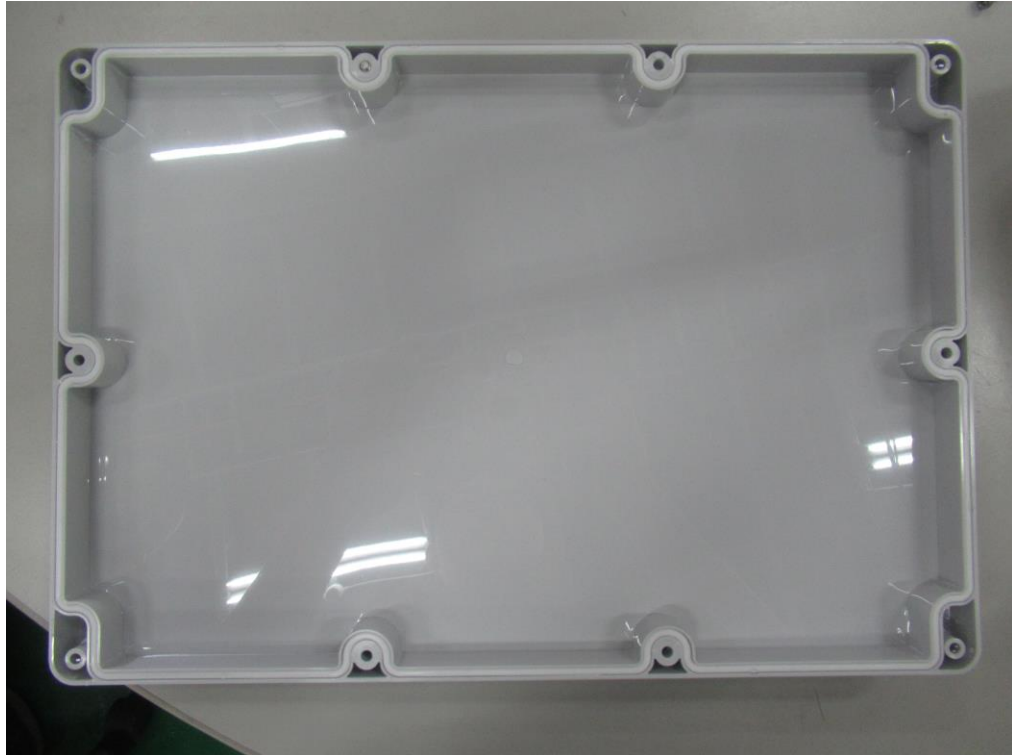
Sealed Plastic Box (PC) P20793-IP68  
IPX8 Test - There is no trace of water inside

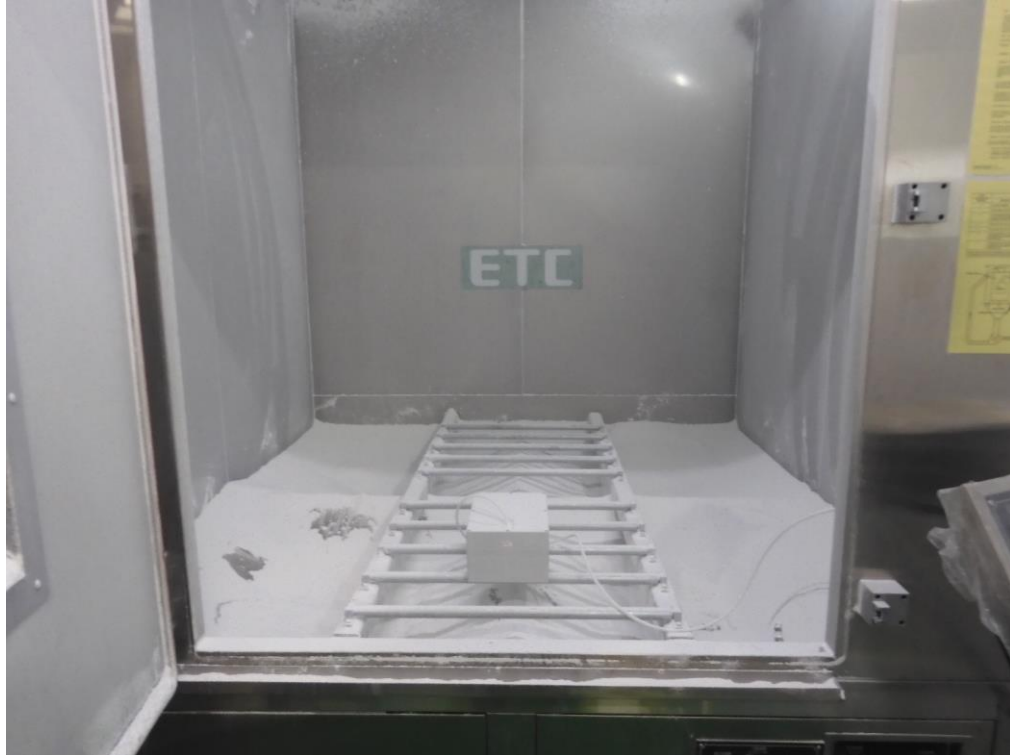
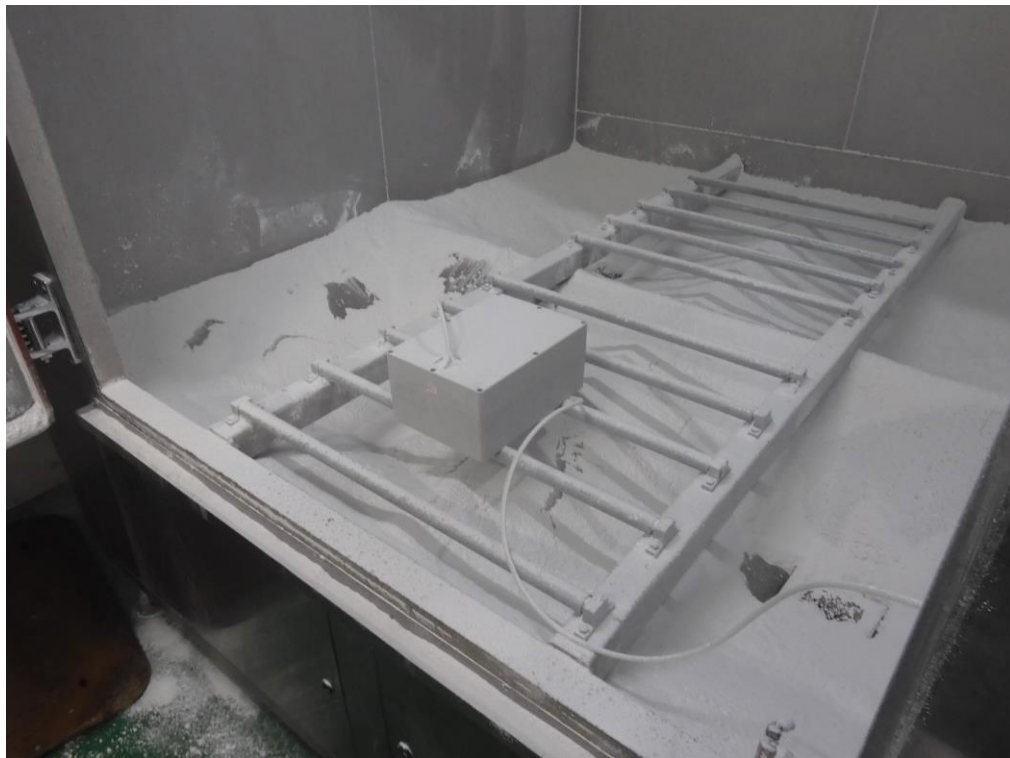
IP6X Test

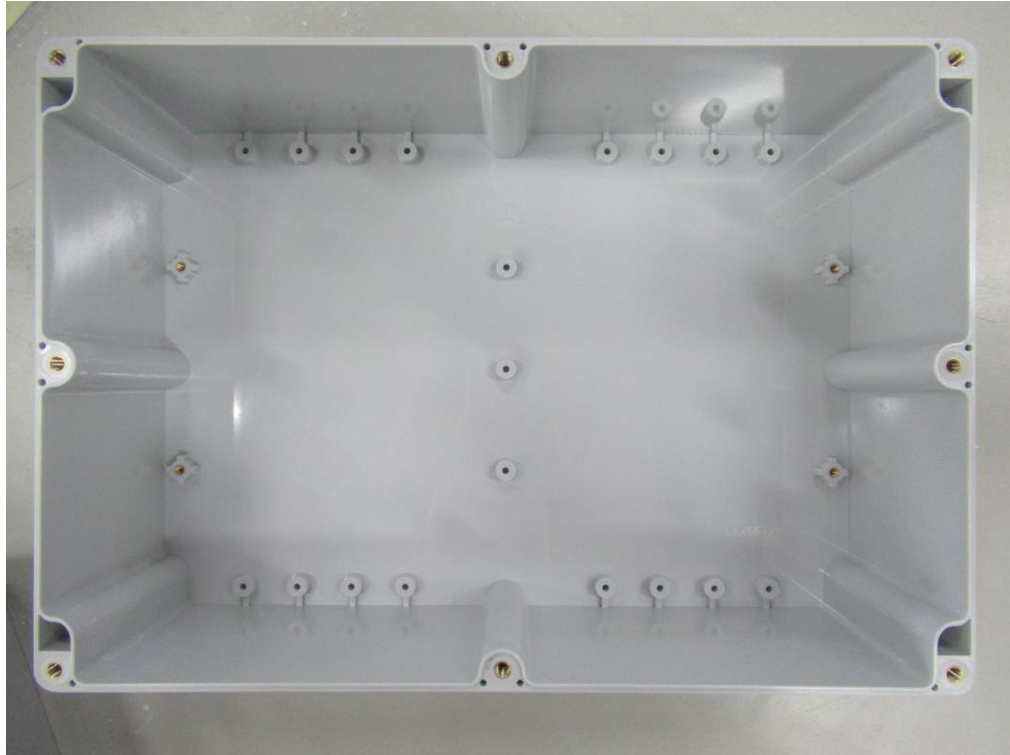
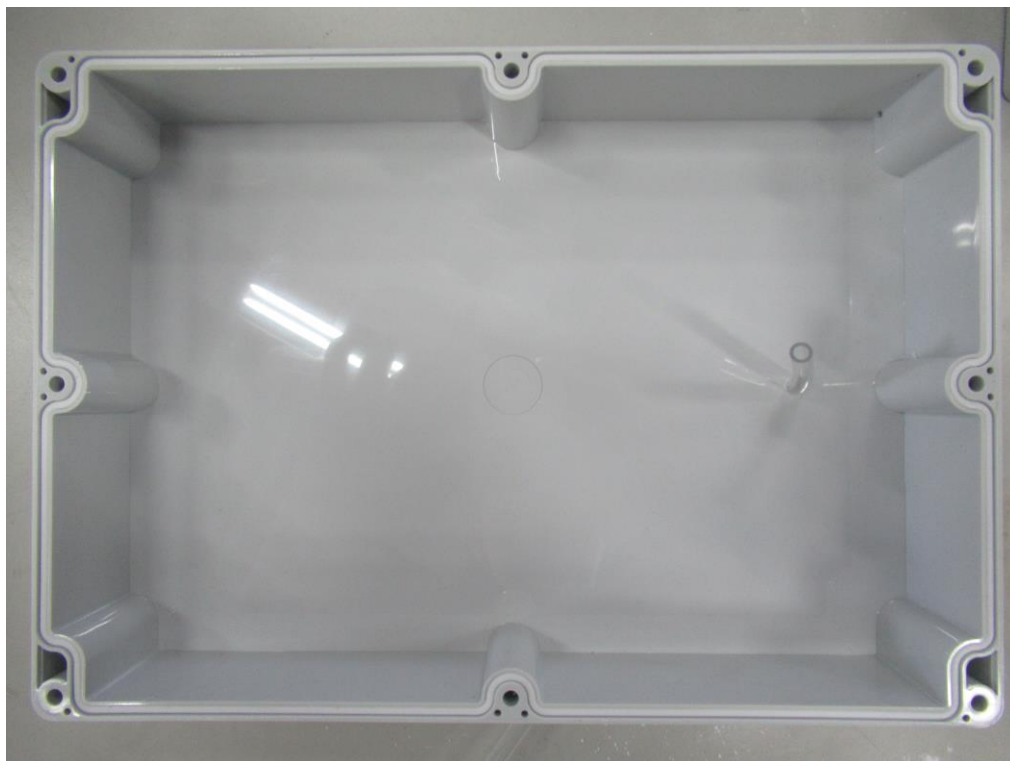
Sealed Plastic Box (PC) P2393-IP68  
IP6X Test - There is no trace of dust inside

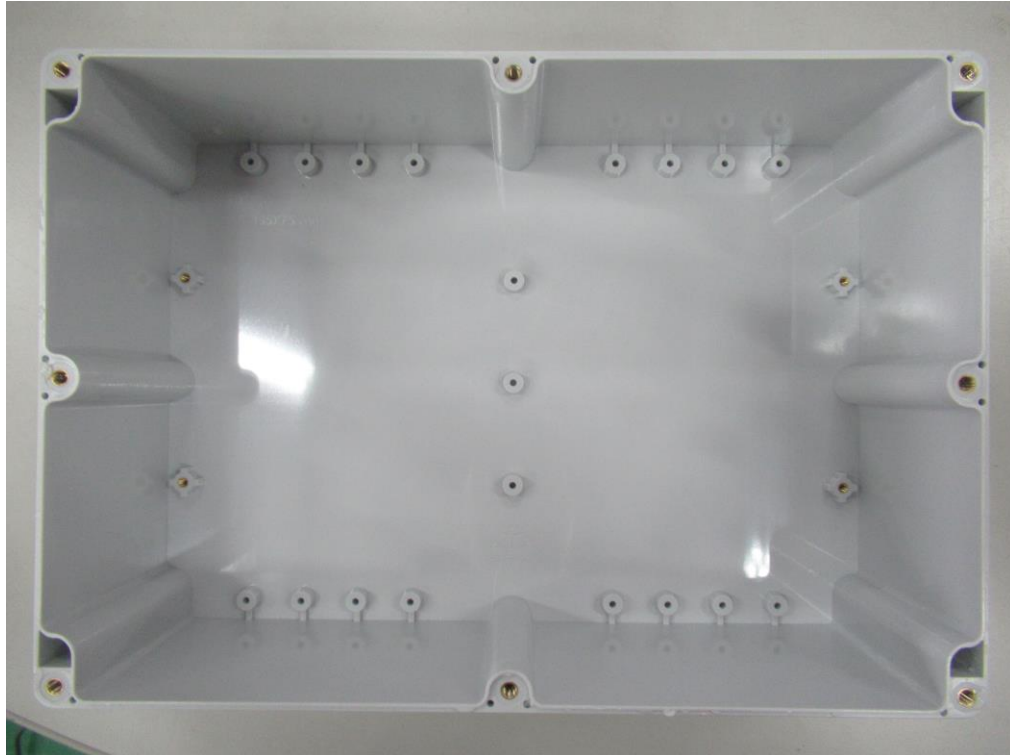
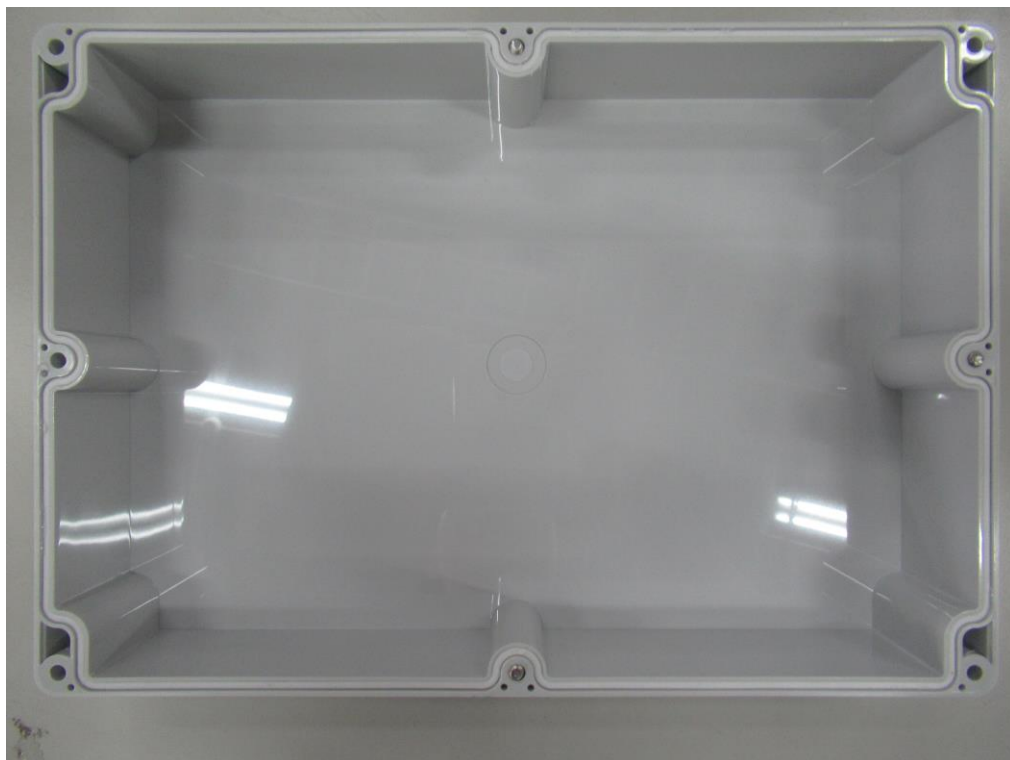
Sealed Plastic Box (PC) P2393-IP68  
IPX8 Test - There is no trace of water inside
